Mod-2 Wind Turbine System Development Final Report

Volume II—Detailed Report

Boeing Engineering and Construction Company
(Division of The Boeing Company)

September 1982

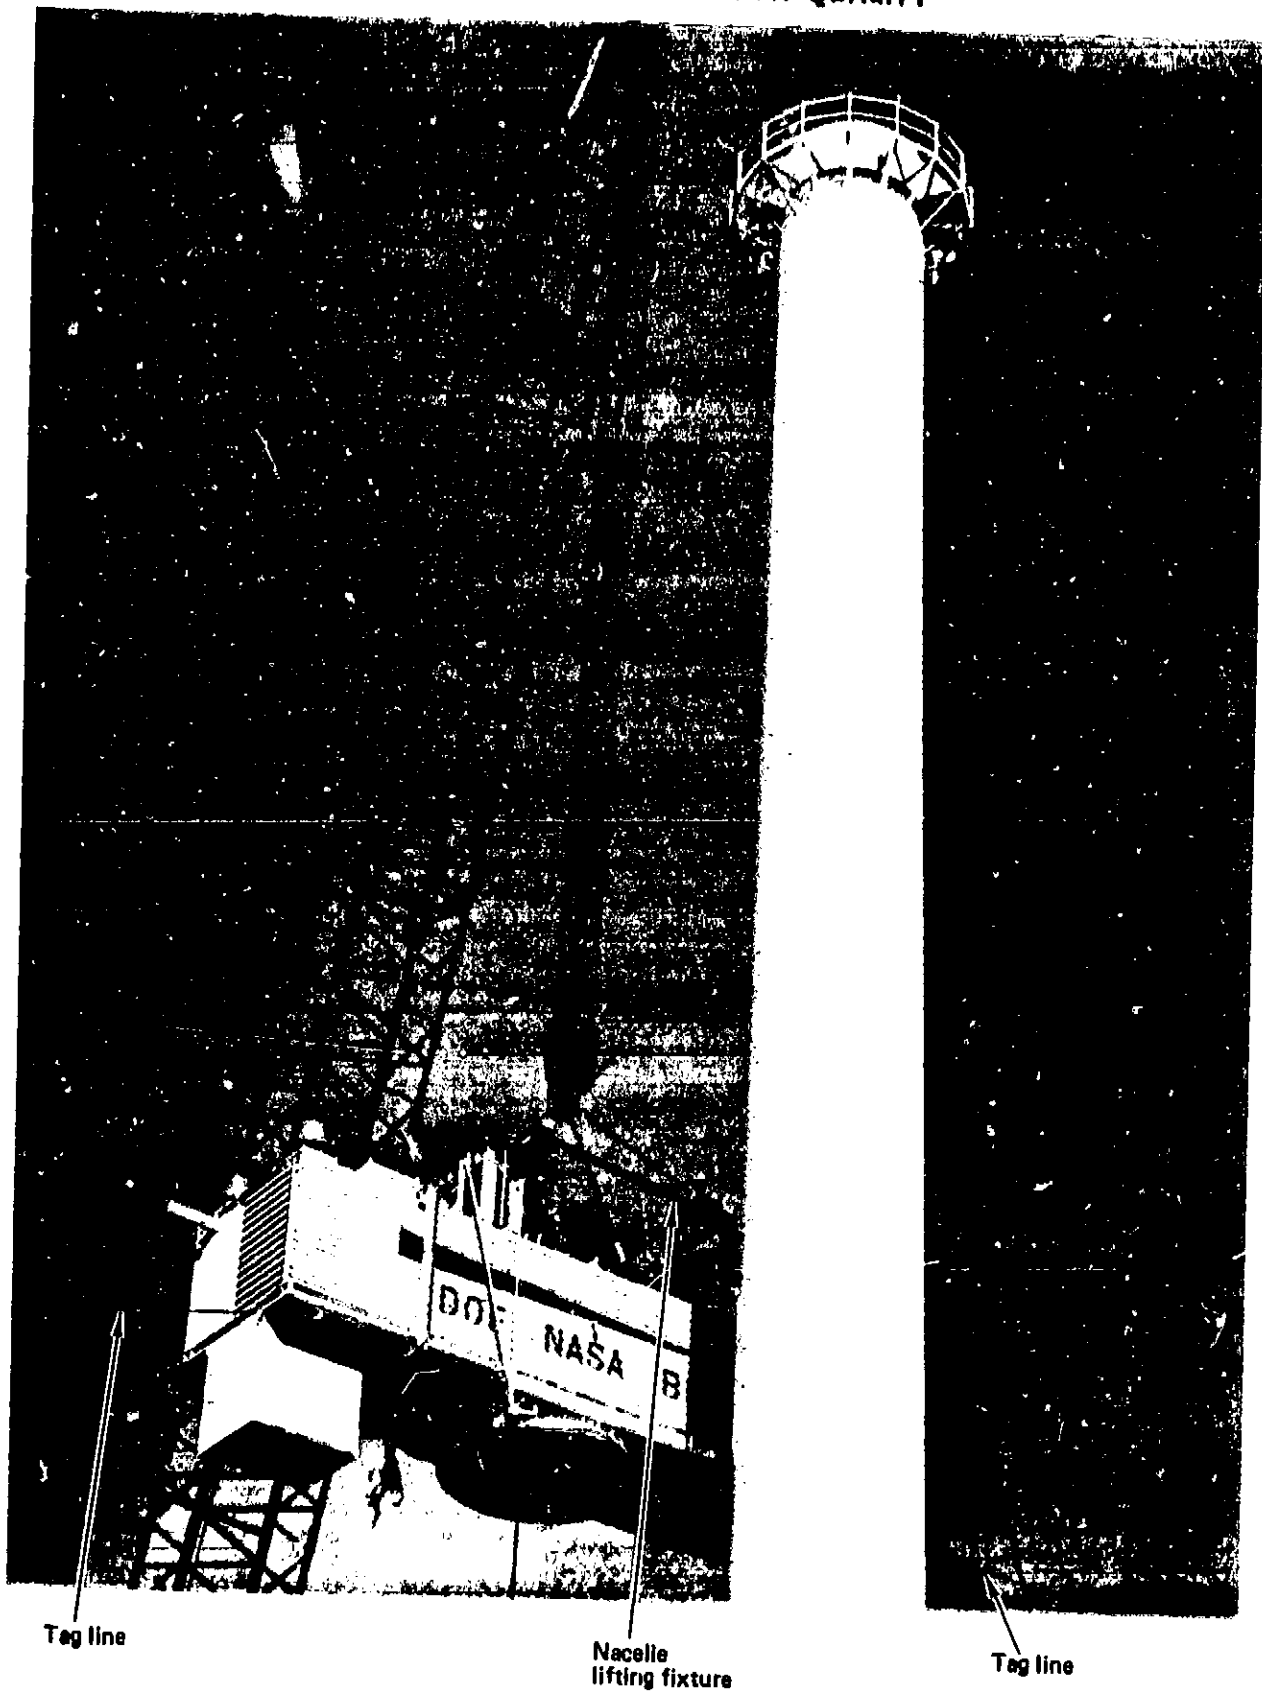
Figure A-5. Nacelle Installation

In preparation for hoisting the nacelle four tag lines were attached to the corners of the nacelle and secured to winches mounted on heavy equipment. These lines were used to stabilize the nacelle during the lift and to align the nacelle as it was set on the top of the tower. A lifting fixture designed for the nacelle lift and previously load tested to 200% of the nacelle weight was pinned to lifting lugs on the nacelle roof (Figure A-4). The nacelle was then hoisted to the top of the tower and bolted in place (Figure A-5). The tag lines were removed, the wind sensors raised and the nacelle was yawed to face the gin pole in preparation of the rotor lift.
